Site 7 - Narberth

7 Technical Criteria

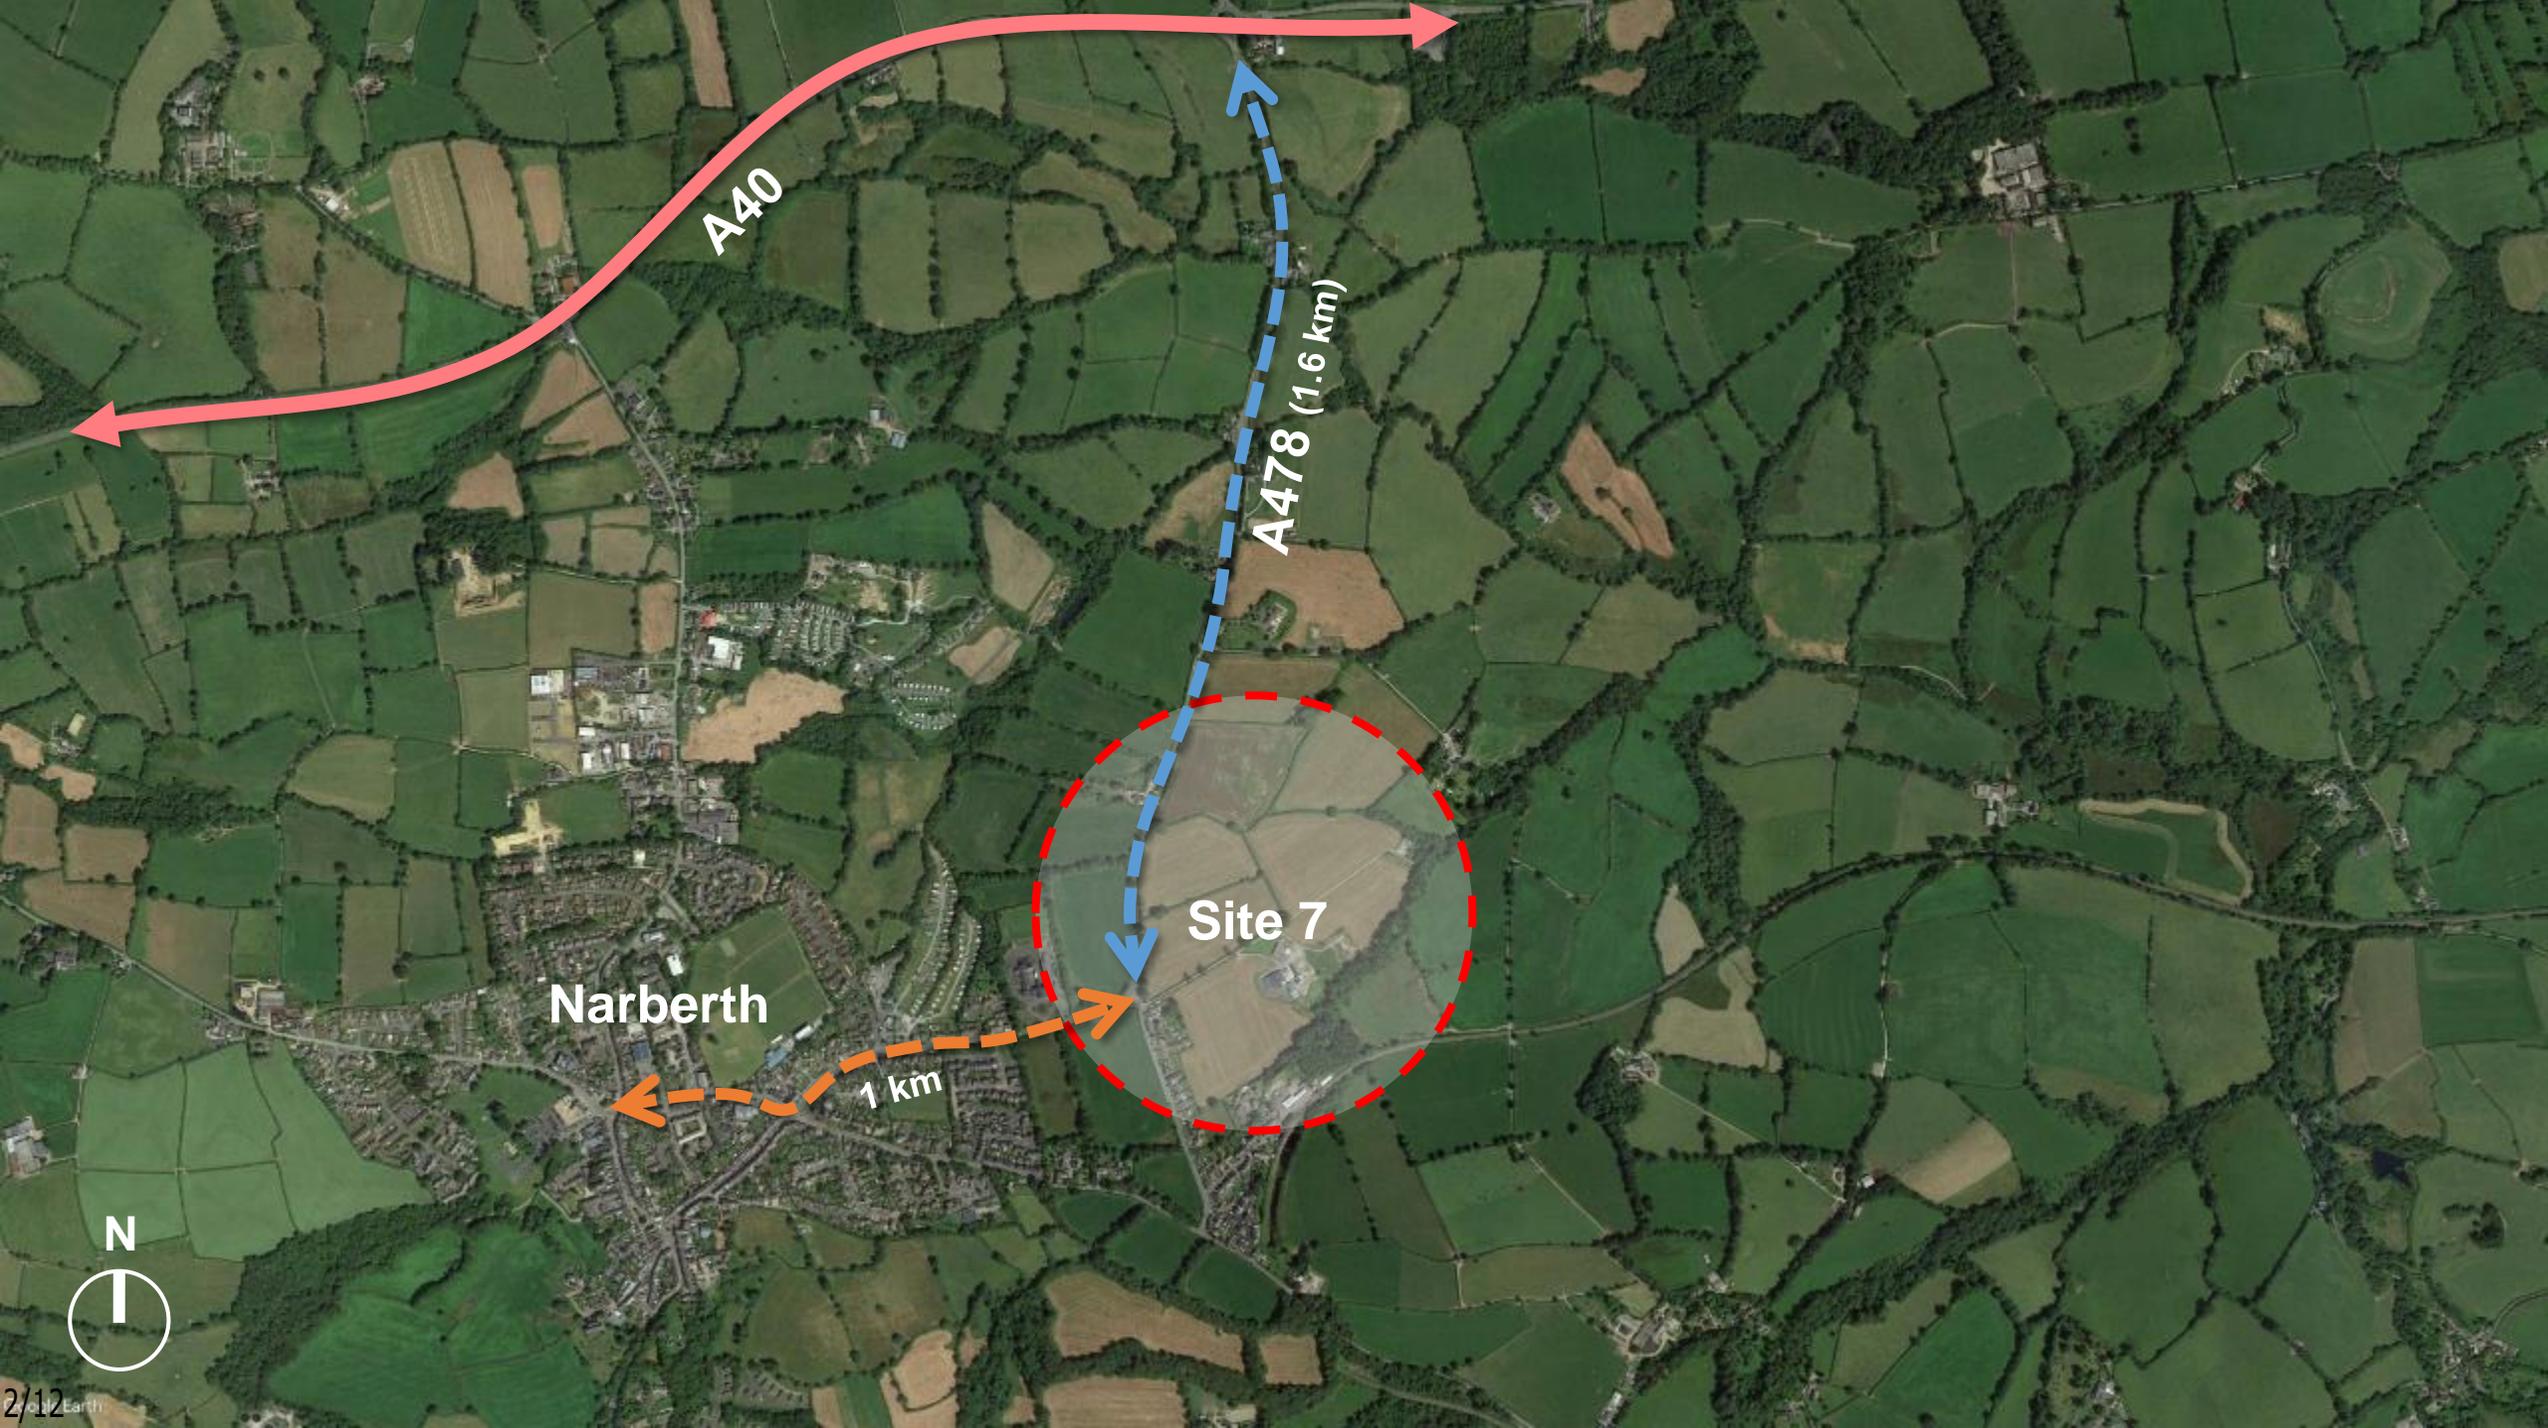
Site 7

A40

A478 (1.6 km)

Narberth

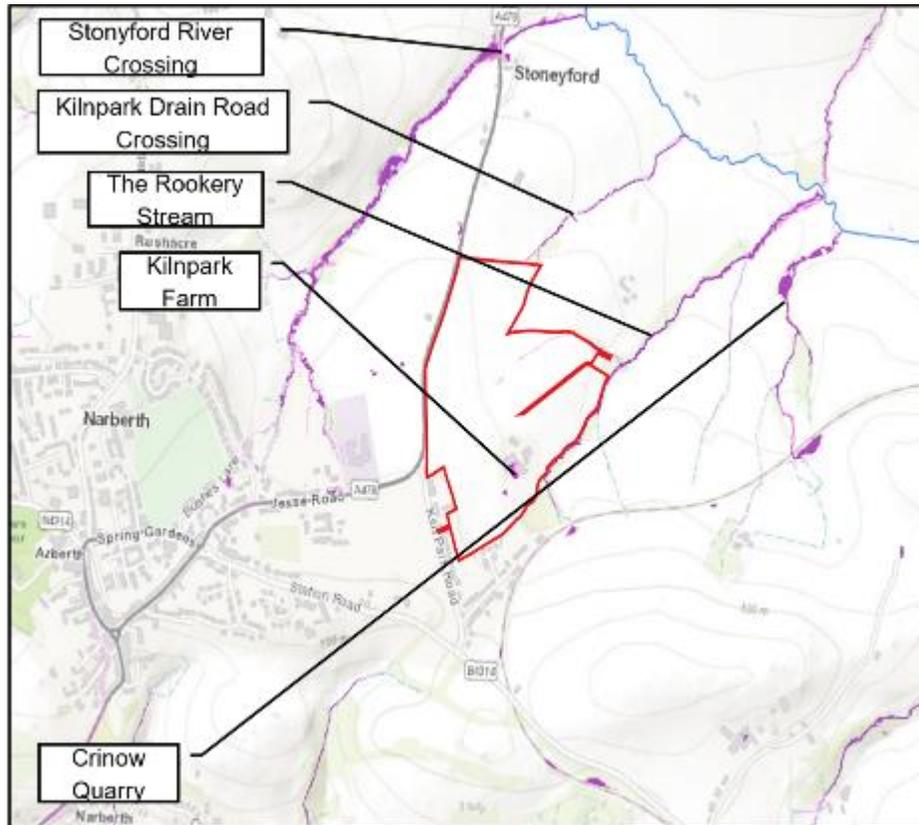
Flood risk plan

- High Risk from Surface Water
- Medium Risk from Surface Water
- Low Risk from Surface Water
- Main River
- Study Area Boundary

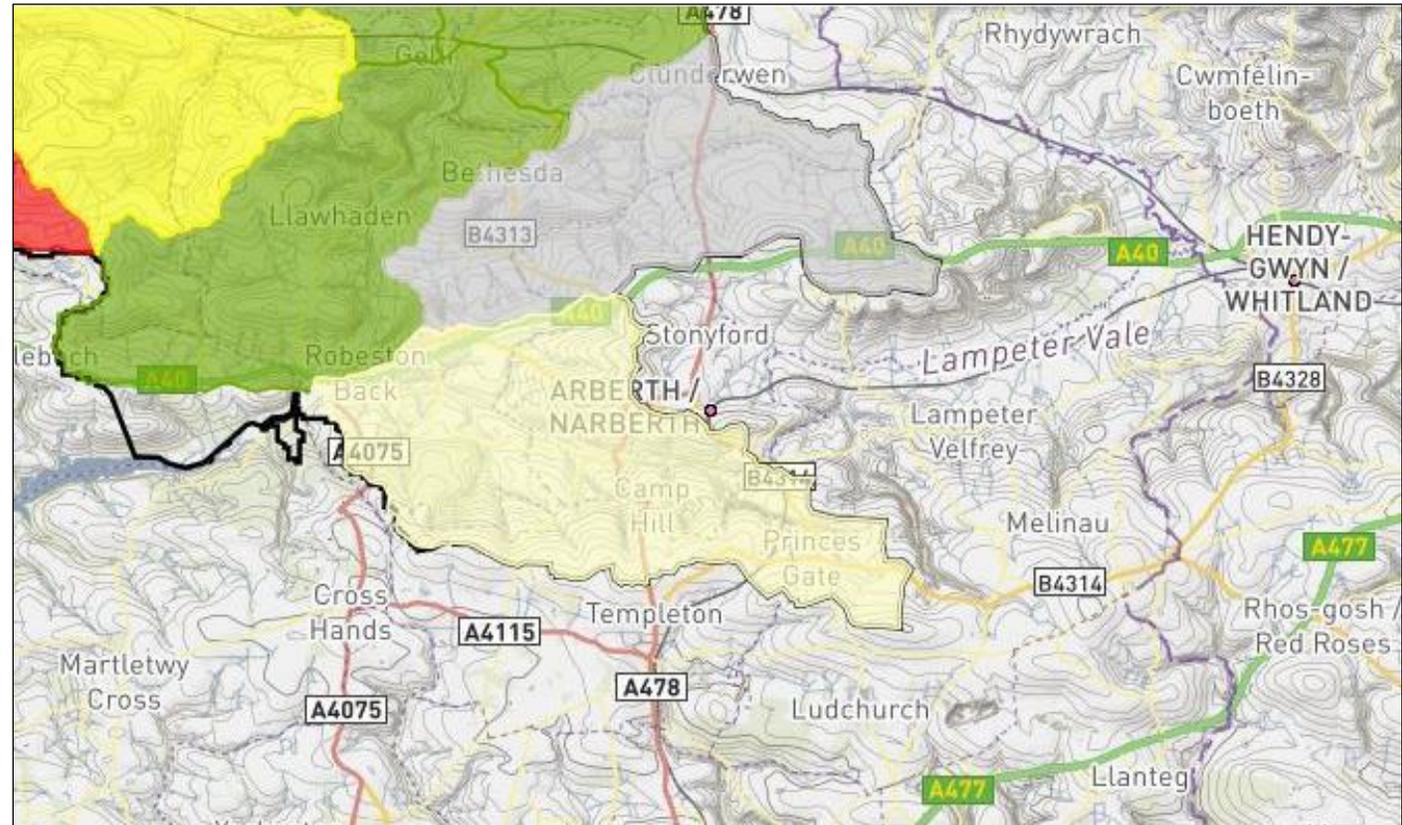
Water quality plan

- Less than 0
- Null
- <10
- 10-20
- 20-30
- >30
